Manhole Inspection Summary

Manhole # S11II_031MH

Insp Date: **10/9/07 4:49 PM**

Location Address: **1800 ELEMONT**

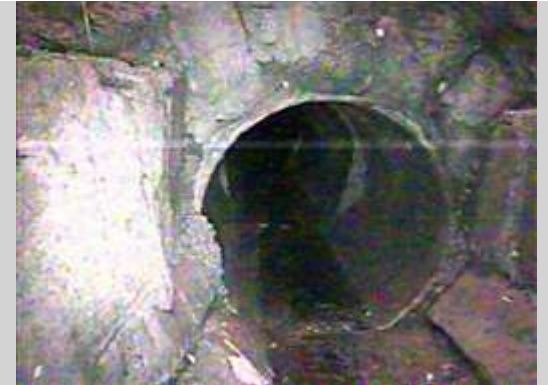
12 O'Clock Outflow

8 in. Circular Gravity Sewer
Pipe Out @ 12 O'Clock

Pipe Material: **Clay** ☐ Pipe Lined

Invert Depth: **7.20** (ft.) Flow Characteristics: **Slow**

Deposits: ☒ None ☐ Mud ☐ Sludge ☐ Debris ☐ Grease

Infiltration: **None** Pipe Seal Cond: **Sound**

Connects To: **Manhole**

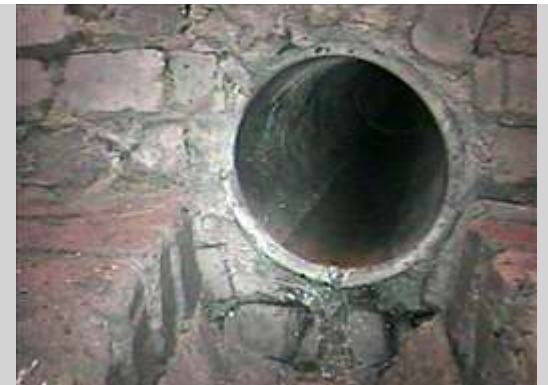
7 O'Clock Inflow

8 in. Circular Gravity Sewer
Pipe In @ 7 O'Clock

Pipe Material: **Clay** ☐ Pipe Lined

Invert Depth: **6.90** (ft.) Flow Characteristics: **Slow**

Deposits: ☒ None ☐ Mud ☐ Sludge ☐ Debris ☐ Grease

Infiltration: **None** Pipe Seal Cond: **Sound**

Connects To: **Connecting Node Not Available**

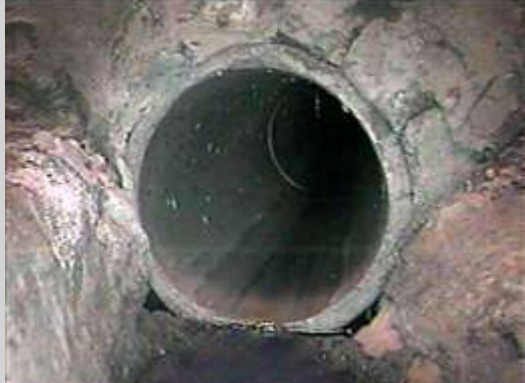
9 O'Clock Inflow

8 in. Circular Gravity Sewer

Pipe In @ 9 O'Clock

Pipe Material: **Clay** ☐ Pipe Lined

Invert Depth: **7.03** (ft.) Flow Characteristics: **Slow**

Deposits: ☒ None ☐ Mud ☐ Sludge ☐ Debris ☐ Grease

Infiltration: **None** Pipe Seal Cond: **Sound**

Connects To: **Stub connection / abandoned**
